Regular Research Article

The Importance of Lifeboat Winch Maintenance for the Safety of Crew and Passengers on the KM Sultan Hasanuddin Training Ship

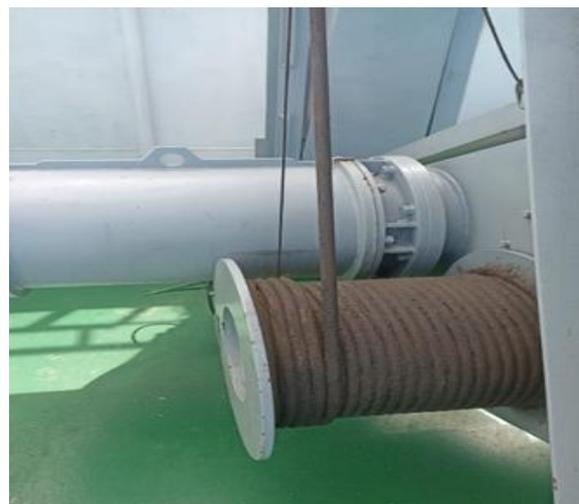
that need to be considered. Corrosion and dirt were found to be attached, as shown in Figure 1. This corrosion is clearly caused by exposure to a highly corrosive marine environment due to high salt content and humidity around the deck. Rusty wire ropes have the potential to experience a reduction in tensile strength so that they are no longer able to withstand loads according to specifications. If this condition is left unaddressed without regular lubrication and replacement, the possibility of the rope breaking during operation will increase. In terms of safety, this is very dangerous because wire rope failure can cause the lifeboat to fall suddenly or be unable to be lowered at all in an emergency.

Figure 1. Condition of the wire rope on the lifeboat wire drum

Figure 1 displays a wire rope wound around a lifeboat wire drum, showing noticeable signs of deterioration and corrosion. The rope's surface appears heavily covered in a brownish, rusty residue and dirt, suggesting a lack of sufficient lubrication and exposure to harsh marine or outdoor elements. This poor condition is a significant concern for operational safety, as corrosion severely weakens the rope's tensile strength and structural integrity, increasing the risk of failure during an emergency deployment of the lifeboat. Furthermore, the rusty deposit indicates a compromised protective layer and potential wear on the individual wires, underscoring the immediate need for a thorough inspection,

maintenance, and likely replacement of the wire rope to ensure the lifeboat system remains reliable and compliant with safety regulations. In addition to the condition of the wire rope, the nameplate on the winch, as shown in Figure 2, which should contain technical specifications such as Safe Working Load (SWL), capacity, type, and other important data, appears blurred and rusty. This condition makes the technical information difficult to read. In fact, this information is the main guideline for operators to avoid operating the winch beyond its capacity limits. If the capacity limit is unknown or ignored, the risk of overloading increases. Other components such as bolts, nuts, and pulleys also show signs of wear and rust. Although the ship's deck appears clean and well-maintained visually, the condition of the main components of the lifeboat winch does not receive the same attention. This indicates that the focus of maintenance is more on environmental cleanliness rather than on the technical maintenance of safety equipment.

lubricated regularly to prevent corrosion, while nameplates should always be legible so that operators are aware of the safe capacity. With these findings, it can be stated that maintenance is more corrective (performed after a problem occurs) than preventive (to prevent damage).

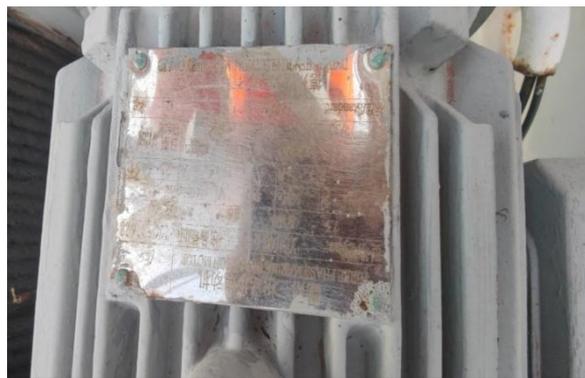
Figure 2. Lifeboat winch nameplate

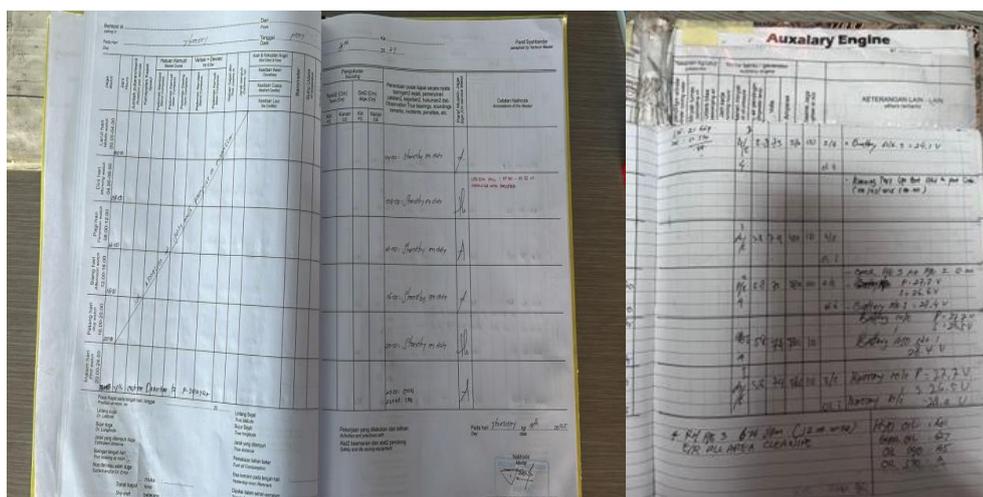
Figure 4. Deck (a) and Engine (b) Logbook Entries

Figure 4 shows the ship's deck and engine logbook, which indicates that drills were indeed conducted on May 8, 2024, and March 29, 2025. However, these activities were not followed or witnessed by passengers. This shows that the drills were carried out more to fulfill administrative obligations than to build collective preparedness on board. In general,

According to the Deck and Engine Logbook, lifeboat drills were indeed conducted twice during the research period. However, the drills did not involve passengers. In fact, SOLAS Chapter III requires everyone on board to participate in evacuation drills [18]. Drills that only involve the crew are not effective enough to build comprehensive preparedness. Thus, even though drills are recorded, their effectiveness is still low because they do not meet standards. Based on these three indicators, the lifeboat winch maintenance program on KM Sultan Hasanuddin is considered ineffective. The equipment shows physical degradation, PMS documentation is unavailable, and drills are not conducted in accordance with international standards. This increases the risk of equipment failure during emergencies.
