# Implementation of SOLAS Compliant Life Saving Appliances to Support Safety on Board the KM. Armada Segara

Abiyyu Ikbar Sriwandana\*, Kuncowati and Elva Febriana Anggraeny

Universitas Hang Tuah Surabaya, Indonesia

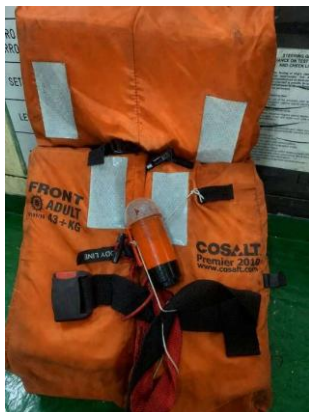
Figure 1. Life jackets on the KM. Armada Segara in 2025

A routine examination revealed that some

of the life jackets in Figure 1 were discolored and had malfunctioning emergency lights. Numerous significant conclusions that must be taken into account are revealed by the field observations. First, every ship is required by SOLAS standards to have as many life jackets as crew members. This criterion has been satisfied with 29 life jackets on the KM. Armada Segara. Nevertheless, it was discovered that four of them had issues with their emergency lighting systems. These circumstances may lead to malfunctions in the safety equipment, particularly during nighttime emergencies or low-visibility scenarios where lighting is essential for identifying victims on the water's surface.

A limitation in the electronic components of the life jacket was the next problem found. Some life jackets were found to have issues with the automatic lighting system, which is meant to turn on when it comes into contact with water. Because the light acts as a beacon to help with identification in low-visibility situations, this function is essential.

This study recommends three improvements to enhance the LSA function in protecting the crew's lives: (1) immediate technical repairs to the davit system and malfunctioning life jacket components; (2) improving the quality of drills by using more realistic scenarios to build solid team readiness, rather than merely procedural compliance; and (3) fostering a sustainable safety culture among the entire crew. To ensure that the LSA readiness on the KM. Armada Segara is truly optimal both in terms of regulations and operations these three steps must be implemented simultaneously.

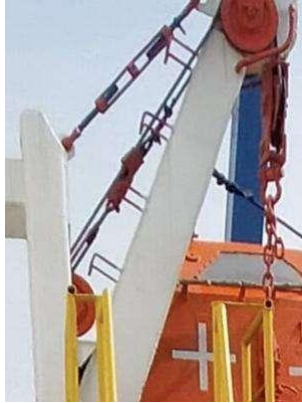
Chapter III of the SOLAS Convention, which states that all equipment used to lower lifeboats must operate correctly in compliance with the ship's SOP, is not yet met by the lifeboat davits

aboard the KM. Armada Segara.

Figure 2. Lifeboat Davits on the KM. Armada Segara in 2025

The Davits system's state is depicted in Figure 2, which calls for additional repairs, including mechanical parts that seem to be having problems. Every ship is required by SOLAS standards to have two lifeboats. This condition has been satisfied on the KM. Armada Segara. Nevertheless, the lifeboat davits system was found to have a technical problem that made it unusable, making it unable to raise the lifeboats back on board after launch. This problem is still a major worry even though it does not affect the principal purpose of davits in emergency evacuations, which is to safely lower lifeboats to the water's surface. To stay completely functional, this one-way davit system needs constant, comprehensive maintenance, especially in relation to its capacity to raise lifeboats back on board.

| LSA Item | SOLAS Chapter III Requirements | Actual Conditions on Board | Compliance Status | Deficiency/Maintenance Notes |
|---|---|---|---|---|
| Lifeboat davits | Descent aids must be operated in accordance with the vessel's Standard Operating Procedures (SOP) (SOLAS Reg. 20) | The drop function works as usual, but the pick-up function isn't working | Not entirely accurate | The davit system operates in only one direction; testing of the davit, winch, and release gear in accordance with SOLAS Regulation 20 has not yet been completed |

Technical difficulties are the primary barrier to installing Life Saving Appliances (LSA) on the KM. Armada Segara, according to the findings of observations and interviews. The lifeboat davit system's malfunction during retrieval operations is one particularly serious problem. According to the Third Mate, testing of the release equipment, including the davits, winches, and release gear, in compliance with SOLAS Regulation 20 has not been finished because of technical constraints in the mechanical components.

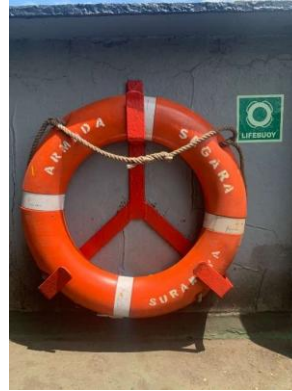
Chapter III of the SOLAS Convention, which mandates that ships between 60 and 120 meters in length must carry at least 12 lifebuoys, is met by the life jackets on board the KM. Armada Segara.

Lifebuoys are arranged thoughtfully throughout the ship's areas in Figure 3. There are thirteen lifebuoys in good shape, each with a marking system that uses reflective stickers, demonstrating that these requirements have been met and even exceeded. These stickers help with visual identification at night or in low-visibility emergency circumstances. Lifebuoys must be rapidly and easily accessible, which is a crucial consideration in their placement. High-risk locations, like loading and unloading areas

and working decks, should be prioritized.

Figure 3. Lifebuoy on the KM. Armada Segara in 2025

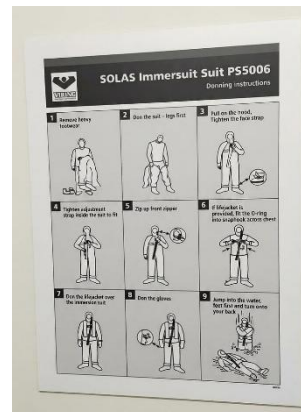
Chapter 3 of the SOLAS Convention, which stipulates that posters explaining the manual use of Life-Saving Appliances shall be posted on every deck of the ship, is cited in a poster on the KM. Armada Segara that describes the procedures for Life Saving Appliances (LSA).

Figure 4. Poster on Life Saving Appliances (LSA) Procedures on the KM. Armada Segara in 2025

Each deck of the ship has safety posters and placards with visual instructions on how to use Life Saving Appliances (LSA), as shown in Figure 4. This instructional material is presented in a format that is easy for the entire crew to understand, combining clear text instructions with captivating graphic illustrations. All materials are written in both English and Indonesian so that crew members from different countries can understand them.
