## Failure Analysis and Optimization of Main Engine Cooling System Maintenance on a Fishing Vessel: A Case Study of KM. God Bless 08

\*M. Irvan Alfandi Muaimin Jufri, Fahriadi Pakaya, Yurika Nantan, Nyoman Subawa  
Mekanisasi Perikanan Politeknik Kelautan dan Perikanan Bitung  
\*irvanjufri23@gmail.com

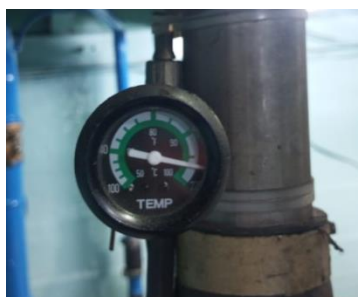
Figure 2. Freshwater Cooling System Temperature Measuring Instrument

When the author collected data from the incoming and outgoing seawater temperatures using a temperature measuring instrument, the sensor directly measured the water temperature by being installed inside the seawater inlet and outlet pipes. This allowed the author to analyze the temperature difference between the freshwater and seawater, enabling the prevention of damage by performing maintenance on the heat exchange area, i.e., the heat exchanger.

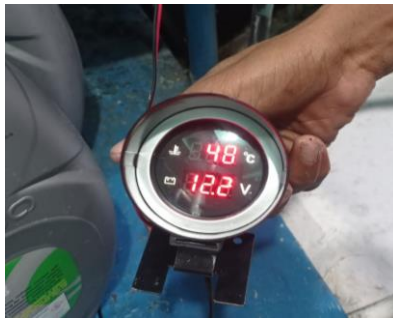
Figure 3. Seawater Cooling System Temperature Measuring Instrument

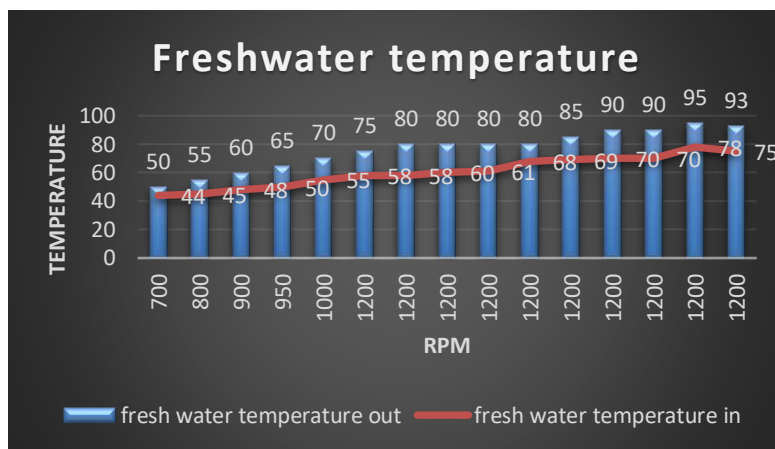
Figure 4. Difference in Freshwater Inlet and Outlet Temperature

In Figures 4 and 5, the difference and temperature variation between the seawater and freshwater inlet and outlet temperatures can be observed. The author analyzes the cooling system's performance using measuring instruments, as shown in Figure 13. The very high temperature at 1200 RPM, reaching 95°C, while the normal temperature is 80°C, is caused by the ineffective heat transfer in the heat exchanger. The high temperature in the engine room, due to insufficient cold air entering the room, causes the room temperature to rise, leading to an increase in engine temperature.

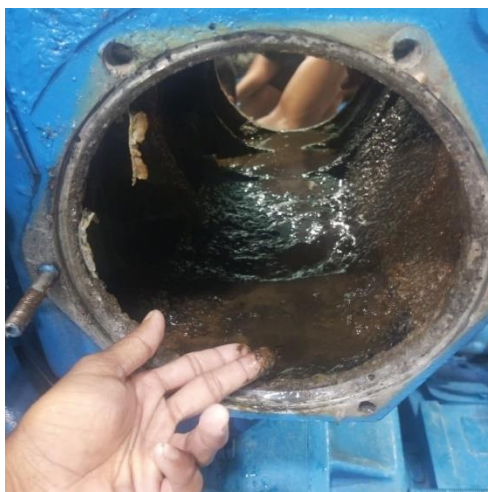
Figure 6. Heatexcahnger

During the dismantling of the main engine's heat exchanger, the dirt attached to the walls of the heat exchanger and in the capillary pipe lines causes ineffective heat exchange because it is obstructed by the dirt, which acts as an insulator. This dirt must be cleaned so that the surfaces of the pipes, which are conductors, can directly absorb heat from the water medium.

Based on the analysis of the temperature differences in the cooling system, maintenance should be performed on the heat exchanger and the capillary pipe routes by cleaning the debris that has accumulated on the surfaces, obstructing the heat transfer from the water to the copper pipes, which are conductors, whereas the debris acts as an insulator.

1. Close the seawater valve to prevent seawater from entering, ensuring that no water flows out when the pipes are opened.
2. Open the nipple bolts to disconnect the pipe joint between the capillary pipe cover.
3. Open the heat exchanger covers, both for the inlet and outlet seawater lines.
4. Remove the capillary pipes inside the heat exchanger.
5. Clean the dirt attached to the walls of the heat exchanger using pressurized water and soap until it is clean.

6. Soak the capillary pipes in Portex for 1 hour and clean the pipe holes using stainless steel wire to remove any rust or barnacles.
7. Clean the dirt attached to the capillary pipe covers as well.
8. Once everything is confirmed clean, reassemble the components, starting with the installation of the capillary pipes and covers using new seals, reinstall the seawater pipe joints, and tighten the locking nipple.
9. Open the seawater valve and ensure there are no leaks in the seawater lines, especially at the pipe joints.

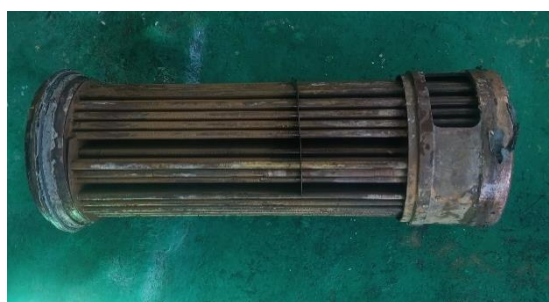
Figure 7. Capillary pipes

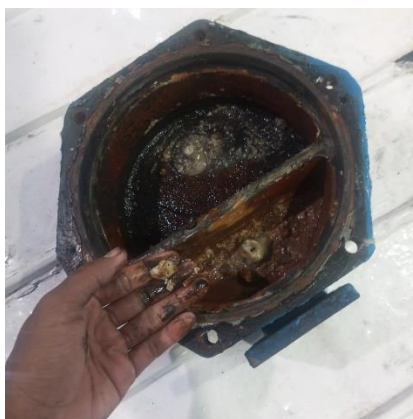
Figure 8. Cover of the heat exchanger pipes

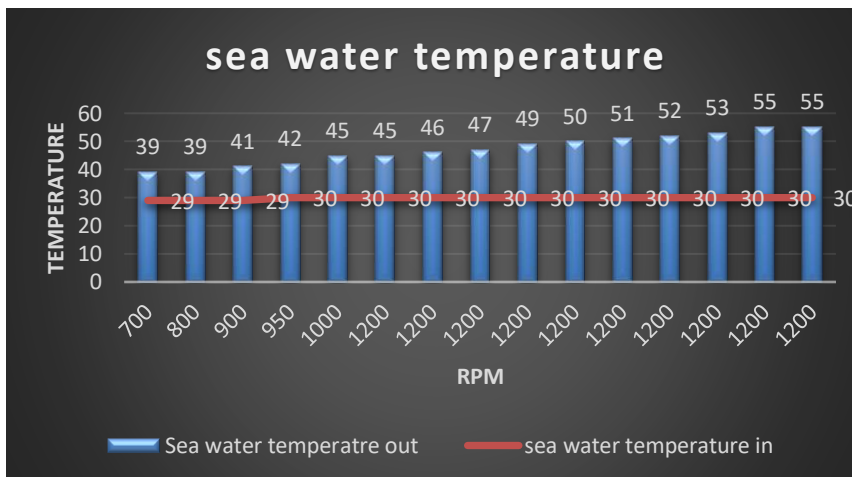
After performing maintenance on the heat exchanger, and operating the engine for 12 hours from when the ship departed from the fishing ground to the fishing base, the temperature of the engine started to normalize, reaching a maximum of 83°C, while the seawater inlet temperature was 57°C, showing a cooling difference of 25°C. Compared to before the maintenance, when the temperature only dropped by 12°C, as shown in Figure 9. The analysis of the improvements in the cooling water temperature is crucial to ensure the cooling system operates normally, preventing a decline in the performance of the main engine, which could hinder the ship's journey.

Figure 10. Difference in seawater inlet and outlet temperature

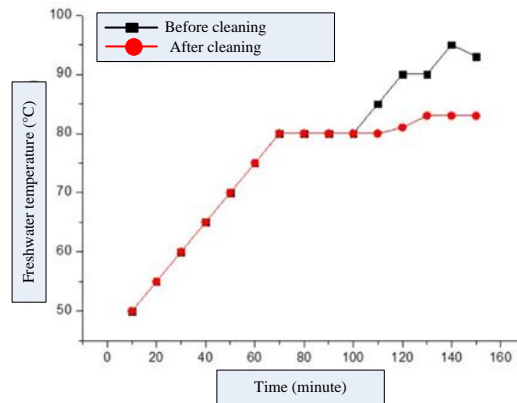
The heat absorbed by the seawater after the maintenance and repair of the heat exchanger is now effective compared to before the maintenance. This can be seen in Figure 11, which shows the difference in the freshwater outlet temperature.

Figure 11. Temperature Difference
