## Cost Estimation for Blasting and Painting Repair Work on KMP. Kormomolin

Nurul Hijrah Bahar\*, Taufiqur Rachman

Departemen Teknik Kelautan, Fakultas Teknik Universitas Hasanuddin, Indonesia

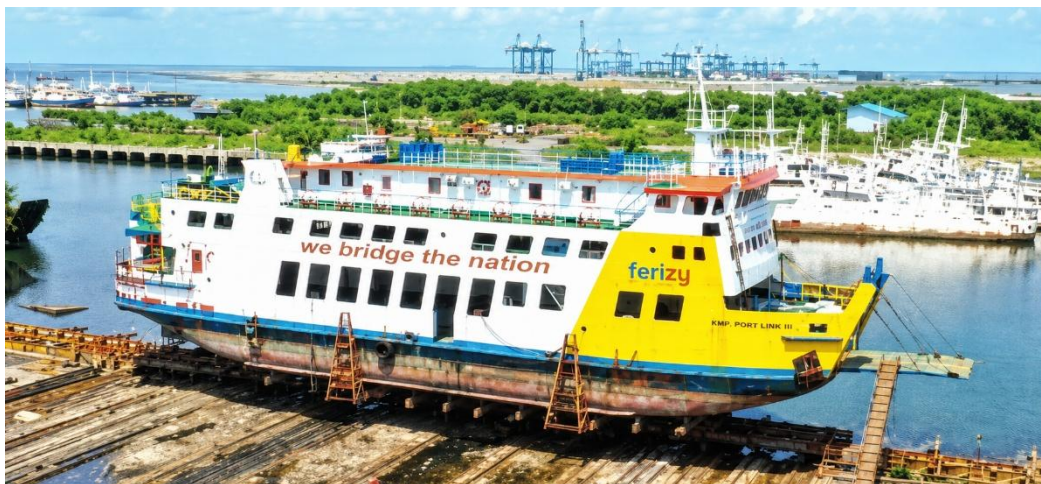
Figure 1. KMP. Kormomolin on the slipway of PT. XYZ shipyard

The research began with the collection of the KMP. Kormomolin repair list, followed by direct observation at PT. XYZ shipyard and interviews with relevant staff and management. The observation was carried out to obtain data related to the actual condition of the vessel, repair workflow, material management, and interaction among divisions during the repair process. Interviews were conducted to obtain more detailed information regarding work handling procedures, material planning, material usage standards, and unit prices applied by the shipyard. Furthermore, the estimation of hull maintenance material requirements was carried out, covering sandblasting and painting activities, followed by the overall material cost recapitulation. The condition of KMP. Kormomolin during docking at PT. XYZ shipyard is shown in Figure 1.
